Manhole Inspection Summary

Manhole # S37CC1006MH

Insp Date: **12/11/06 1:19 PM**

Location Address: **3627 GREENMOUNT AVE**

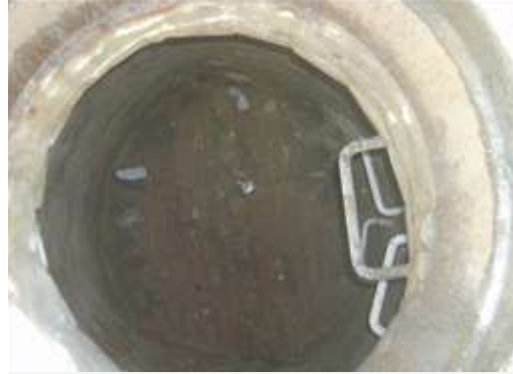
Top View

Channel debris.

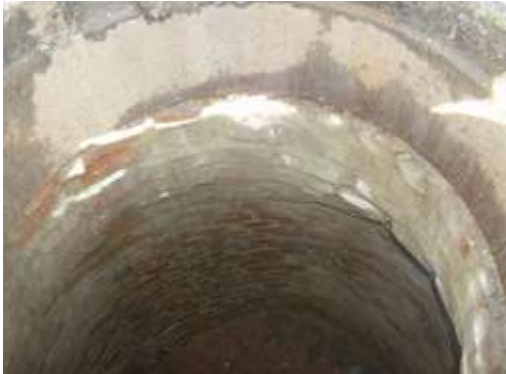
Defect

Frame leaks. Adjustment deterioration and infiltration. Barrel infiltration.

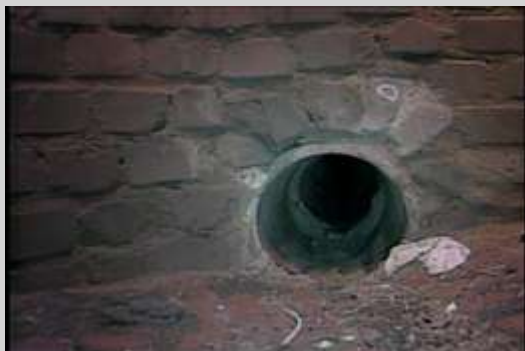
8 in. Circular Gravity Sewer Pipe Out @ 6 O'Clock

Deposits: ☐ None ☒ **Mud** ☐ Sludge ☒ **Debris** ☐ Grease

Silt Depth: **0** (in.) Deposits Extent: **Light**
